RGNDWM funded R&D project RECHARGING THE FRACTURED AQUIFER THROUGH DEFUNCT BORE WELL FOR SUSTAINABLE DRINKING WATER DEVELOPMENT IN PUDUCHATRAM BLOCK,NAMAKKAL DISTRICT-TAMILNADU

R&D Cell. TWAD Board. 31.Kamaraiar salai.Chepauk.Chennai 600005

RECHARGING THE FRACTURED AQUIFER THROUGH DEFUNCT BORE WELL FOR SUSTAINABLE DRINKING WATER DEVELOPMENT IN KARUKURICHI VILLAGE PUDUCHATRAM BLOCK ,NAMAKKAL DISTRICT-TAMILNADU

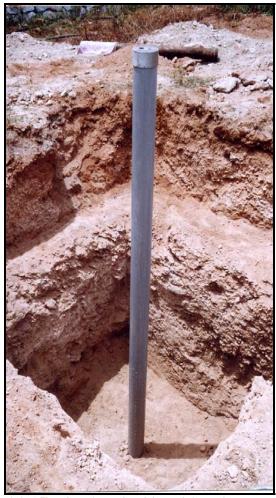
1*1*1.5 The telescopic trench and the newly inserted perforated PVC casing pipe.

20 mm blue metal has been filled up for 0.5 m thickness and the perforated slot is wrapped up with nylon mesh. Pumping hours have been considerably reduced since the aquifer parameters have been improved.
