RGNDWM funded R&D project RECHARGING THE FRACTURED AQUIFER THROUGH DEFUNCT BORE WELL FOR SUSTAINABLE DRINKING WATER DEVELOPMENT IN PUDUCHATRAM BLOCK,NAMAKKAL DISTRICT-TAMILNADU

R&D Cell. TWAD Board. 31.Kamaraiar salai.Chepauk.Chennai 600005

RECHARGING THE FRACTURED AQUIFER THROUGH DEFUNCT BORE WELL FOR SUSTAINABLE DRINKING WATER DEVELOPMENT IN KARUKURICHI VILLAGE PUDUCHATRAM BLOCK ,NAMAKKAL DISTRICT-TAMILNADU

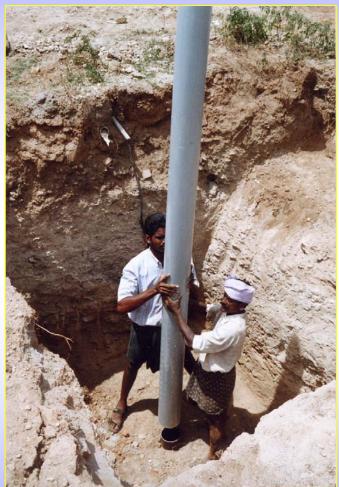
Defunct Bore Well in Karukurichi Village, Puduchatram block In Namakkal District

A trench around the defunct bore well provided and the old casing pipe is removed.

A new perforated PVC casing pipe is inserted in place of the corroded casing pipe.
